Manhole Inspection Summary

Manhole # S51GG_001MH

Insp Date: **6/9/08 9:28 AM**

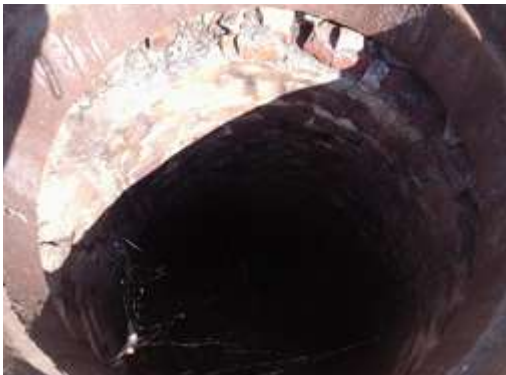
Defect 1

Condition: ☐ Sound ☐ Cracked ☐ Root Intrusion ☒ **Loose Brick** ☐ Deteriorated

LOOSE BRICKS

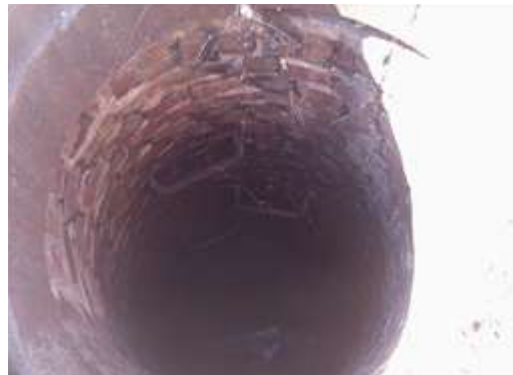
Defect 2

Infiltration: ☐ None ☒ **Joint** ☐ Cracks ☒ **Mortar** ☐ Roots ☐ Wall

INFILTRATION

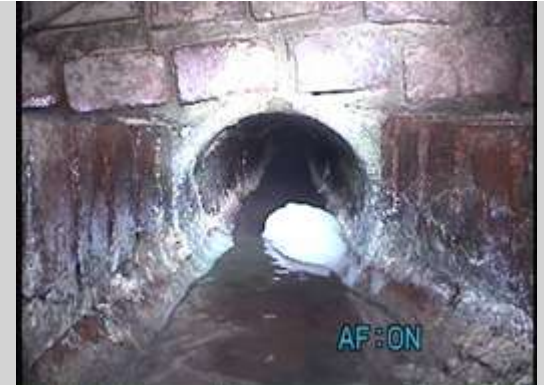
12 O'Clock Outflow

8 in. Circular Gravity Sewer
Pipe Out @ 12 O'Clock

Pipe Height: **8.4** (in.) Rod and Bar (Angled)
Pipe Material: **Clay** ☐ Pipe Lined
Invert Depth: **17.80** (ft.) Flow Characteristics: **Fast**
Deposits: ☒ None ☐ Mud ☐ Sludge ☐ Debris ☐ Grease
Silt Depth: (in.) Deposits Extent:
Infiltration: **None** Pipe Seal Cond: **Sound**

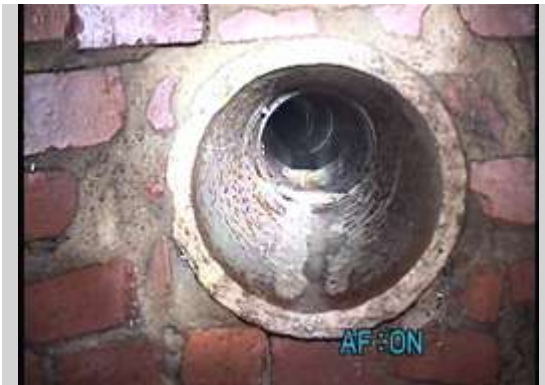
3 O'Clock Inflow

8 in. Circular Gravity Sewer
Pipe In @ 3 O'Clock

Pipe Height: **8.4** (in.) Rod and Bar (Angled)
Pipe Material: **Clay** ☐ Pipe Lined
Invert Depth: **7.85** (ft.) Flow Characteristics: **Fast**
Deposits: ☒ None ☐ Mud ☐ Sludge ☐ Debris ☐ Grease
Silt Depth: (in.) Deposits Extent:
Infiltration: **None** Pipe Seal Cond: **Sound**

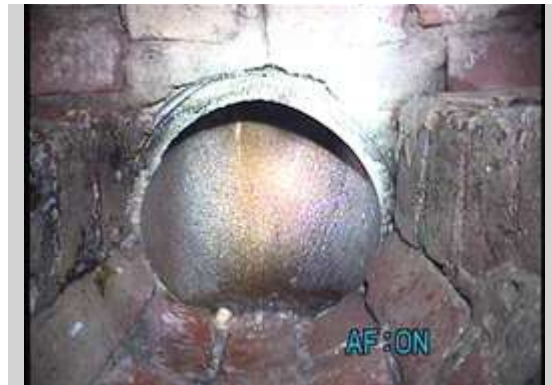
Drop In @ 3 O'Clock

Drop: **Inside** Rod and Bar
Angled: **Yes** Reading: **16.65** (ft.)
Inv Depth: **17.65** (ft.)
Drop Condition: **Open**

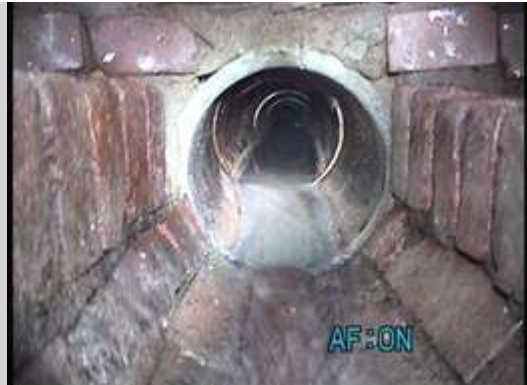
6 O'Clock Inflow

Pipe In @ 6 O'Clock

Pipe Height: **8.4** (in.) Rod and Bar (Angled)

Infiltration: **None** Pipe Seal Cond: **Sound**
